## **Fluvial dynamics and selected methods of ecohydrological monitoring of restored Sviňovický brook channel**

ZDENĚK KLIMENT<sup>1</sup>, MILADA MATOUŠKOVÁ<sup>1</sup>, MIROSLAV ŠOBR<sup>1</sup>,  
MARKĚTA POTŮČKOVÁ<sup>2</sup>, JANA HUJSLOVÁ<sup>1</sup>

<sup>1</sup> Charles University in Prague, Faculty of Science,  
Department of Physical Geography and Geoecology

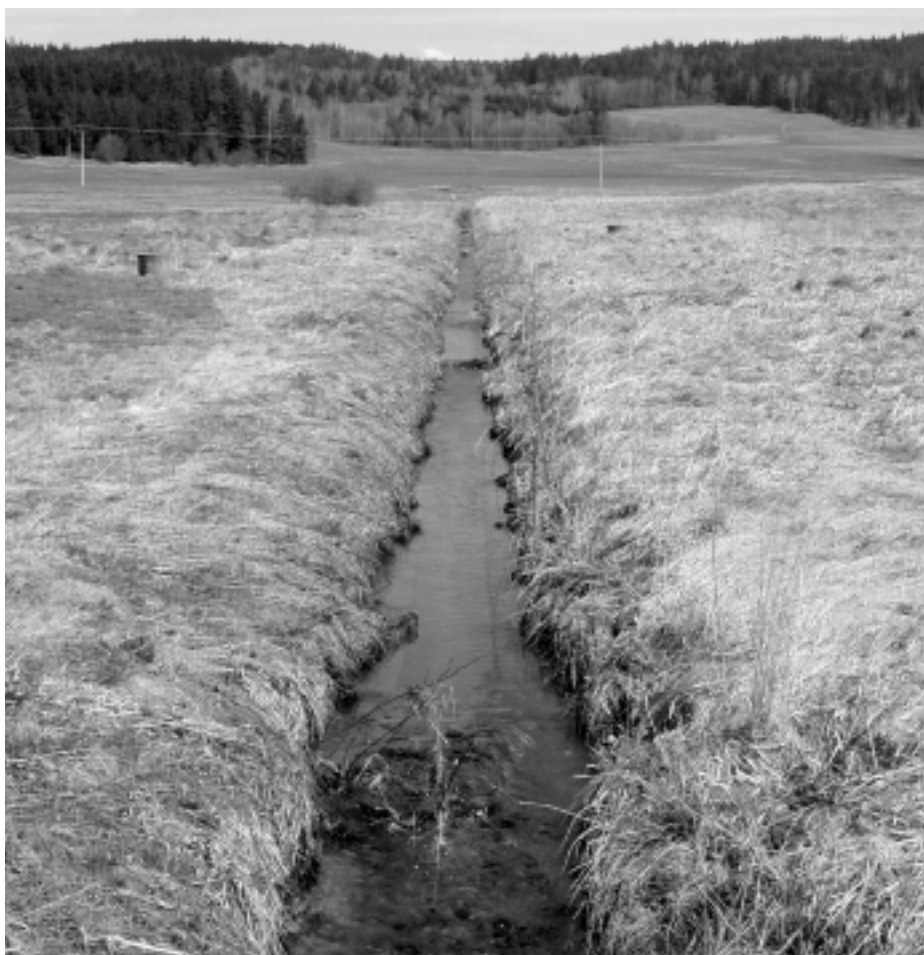
*Figure 2:* Sviňovický Brook before the restoration, the channel bed and the banks were reverted with concrete components – situation in autumn 2004. Photo: Matoušková

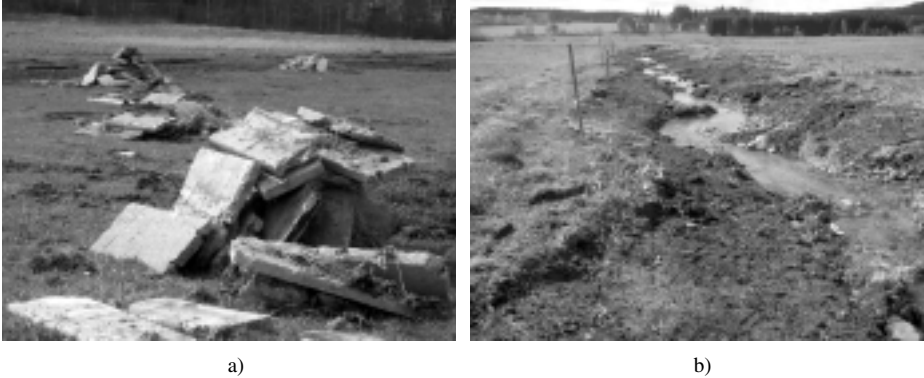
Figure 3: Restored channel of the Sviňovický Brook: a) removed concrete revetment, b) restored channel, closing of the subsurface drainage outlets – situation spring 2005. Photo: Matoušková

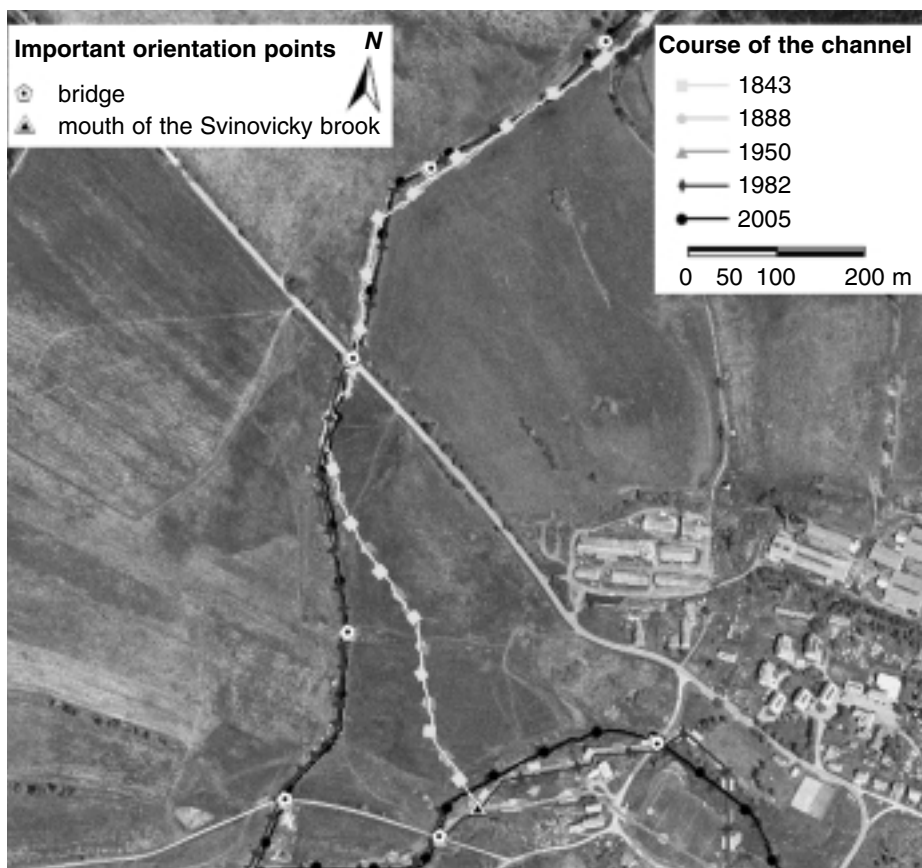
Figure 5: Historical changes in the course of the Sviňovický Brook and the reach of the Zbytinyký Brook between 1843 and 2005

1982, orthoimage of the upper part of Blanice from 2005 – COSMC source). After processing the map sources, the course of the Sviňovický Brook and part of the Zbytinský Brook were put into vectors in the five monitored years – 1843, 1888, 1950, 1982, 2005 (see Fig. 5). In 1843, the character of the channel of the Sviňovický Brook was natural with gentle bends. It ran south-west and, approximately 180 metres north of the road, it turned to the south. Approximately 100 metres from the road the channel's direction changed from the south to south-east. The Sviňovický Brook emptied into the Zbytinský Brook at the start of the village of Zbytiny. The course of the Sviňovický Brook channel in 1888 and in 1951 display only small differences. In the upper part of the brook above the road, the course is practically identical; in the lower part the bends have moved slightly. The Sviňovický Brook was very significantly affected by human activity during the time of agricultural collectivization during socialism in the 1970s and 1980s when amelioration improvement were carried out. It was straightened and a 1.132 km reach of the channel from the mouth to the Zbytinský Brook was reverted using concrete components into the uniform shape of a trapezoid cross-section profile with an incline of 1 : 1.5. In spring 2005, the above-mentioned partial restoration of the brook and adjacent reach of the Zbytinský Brook under the village of Zbytiny was carried out. The concrete fortification was removed, the channel bank incline was changed and the channel bed was equipped with stone rapids. Small bends were created on the short reach under the road bridge. The restored channel was left to develop spontaneously. The restoration was carried out in a different place than the original course before 1970.

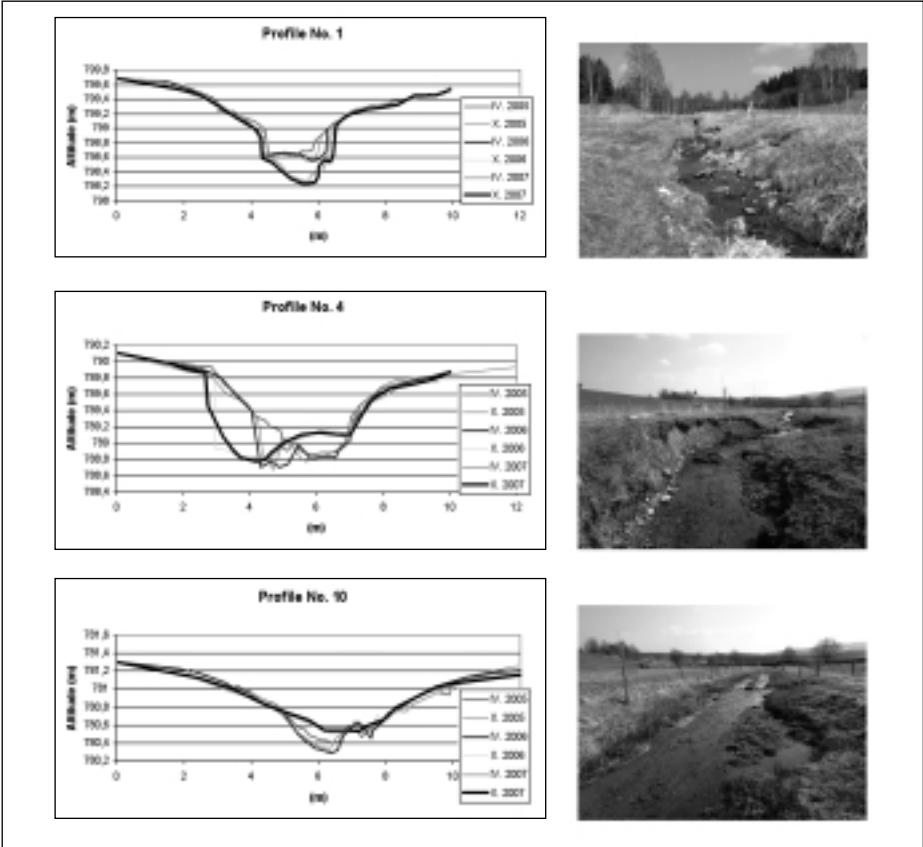
Figure 6: Examples of the cross-section profiles, 2005–2007. Photo: Kliment

of the brook. The changes in the stream bed surface level are up to 40 cm (Fig. 6). While some bends were deepened, the accumulation parts of the profile were filled up, which resulted in the disappearance of other smaller bends. This, in fact, made the channel straight again. Regarding the dynamics of the longitudinal profile of the brook, the road bridge is beginning to be an obstacle to the flow. The last measurements in 2007 and in spring 2008 did not display any significant naturally caused changes in the channel, partly since there were neither significant rainfall-runoff events nor any larger discharge due to the melting of snow cover during this time. The channel is in the same condition as in spring 2006 with some exceptions such as the extension of eroded reaches, the receding of the channel edge (especially in the case of the cut banks), and certain stream bed accumulation and bank erosion at the start and end of the transport reaches (Fig. 7).

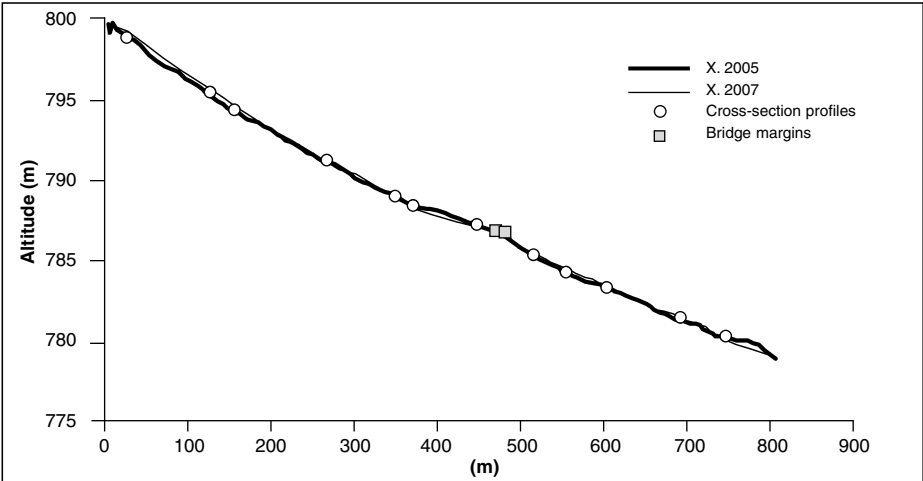
Figure 7: Changes in the longitudinal profile of the restored channel, 2005–2007

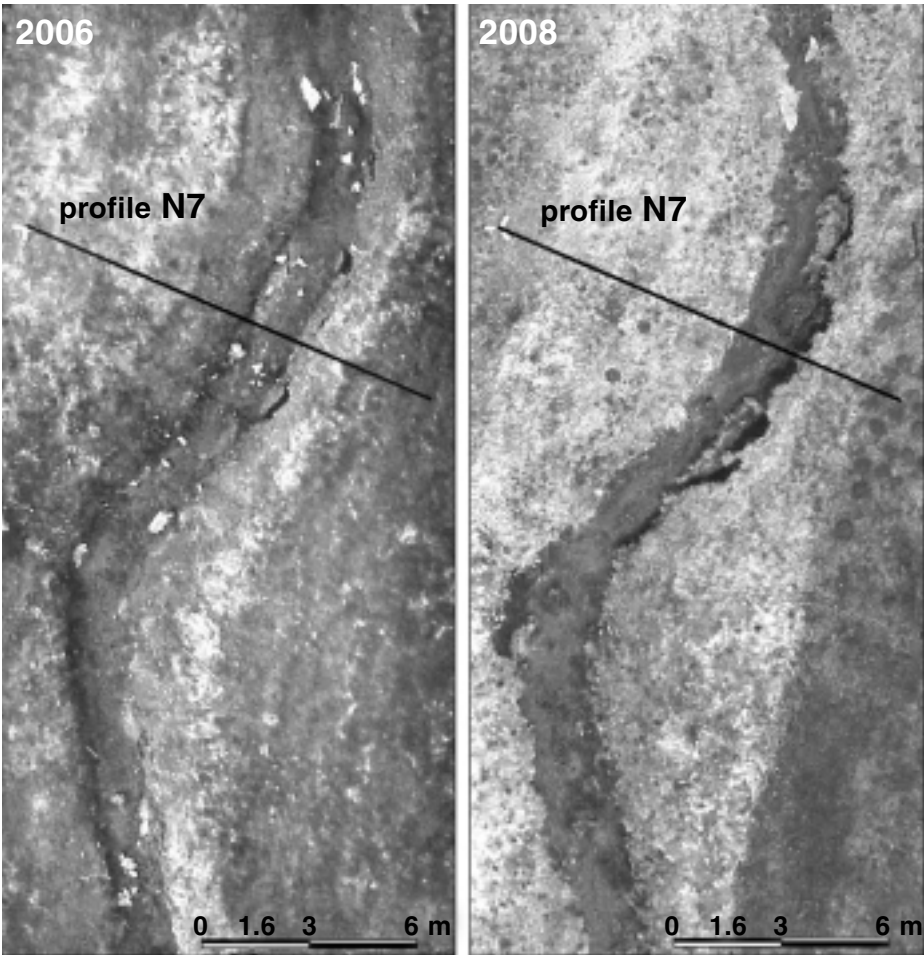
Figure 8: Examples of geo-referenced images taken by flying models in 2006 and 2008 (surrounding of the profile N7)

Fig. 8 and Fig. 9 can serve as examples of the processing and interpretation of the aerial images taken by the flying models in 2006 and 2008. These are images of the restored reach of the channel under the road bridge where, the caving banks were not filled with quarried stones at the end of 2007. The widening of the channel which occurred after the significant rainfall-runoff event in summer 2006, with bank erosion and subsequently falling of wash bank into the channel, is clearly visible in the pictures. Smaller boulders were taken further down the stream. The vegetation growth plays a considerable role in stabilizing the stream bed accumulation.

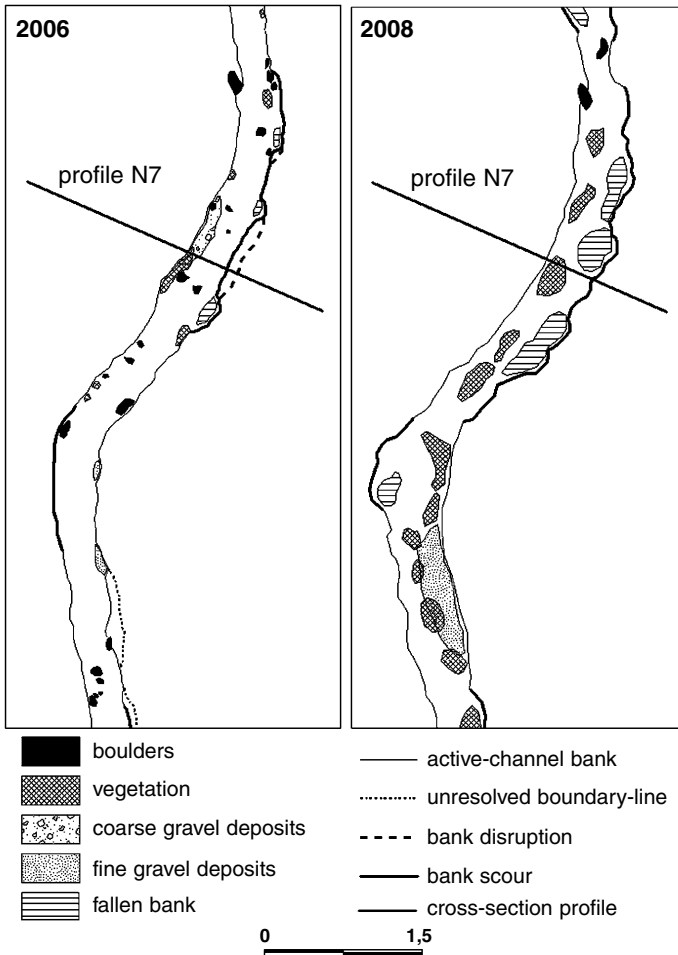
Figure 9: Examples of the interpretation of the images taken by flying models in 2006 and 2008 (surrounding of the profile N7)

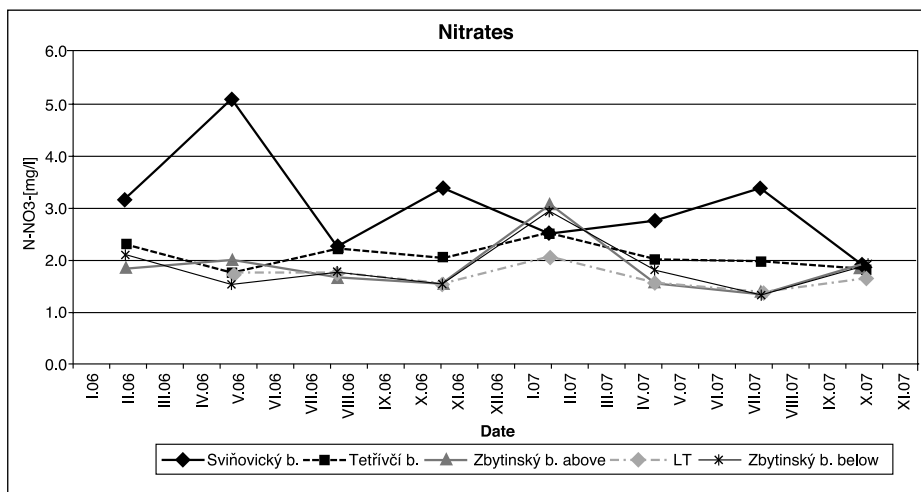
Regarding the parameters of conductivity and N–NO<sub>3</sub><sup>-</sup>, the restored reach of the Sviňovický Brook (the Sviňovický Brook profile) displays the highest burden. An increased concentration of chlorides was identified in this profile. The source of the pollution is probably the intensive cattle farming on the pastures in the immediate vicinity of the channel of the brook. The recorded concentration of N–NO<sub>3</sub><sup>-</sup> falls into the 2<sup>nd</sup> quality class, i.e. only mild pollution – see Fig. 11. The results of the hydrochemical

Figure 11: Concentration of the N-NO<sub>3</sub><sup>-</sup> parameter in the Zbytinský Brook catchment, 2006–2007 (analysis by the Environmental Laboratory, Faculty of Science, Charles University in Prague, K. Hryzáková)

analysis confirmed the existence of a significant point pollution source in the water basin of the Zbytinský Brook: the village of Zbytiny. Specifically, concentrations of COD, conductivity, N-NH<sub>4</sub><sup>+</sup> and P-PO<sub>4</sub><sup>3-</sup> are higher. The situation will undoubtedly improve after the sewage treatment plant Zbytiny comes into operation.

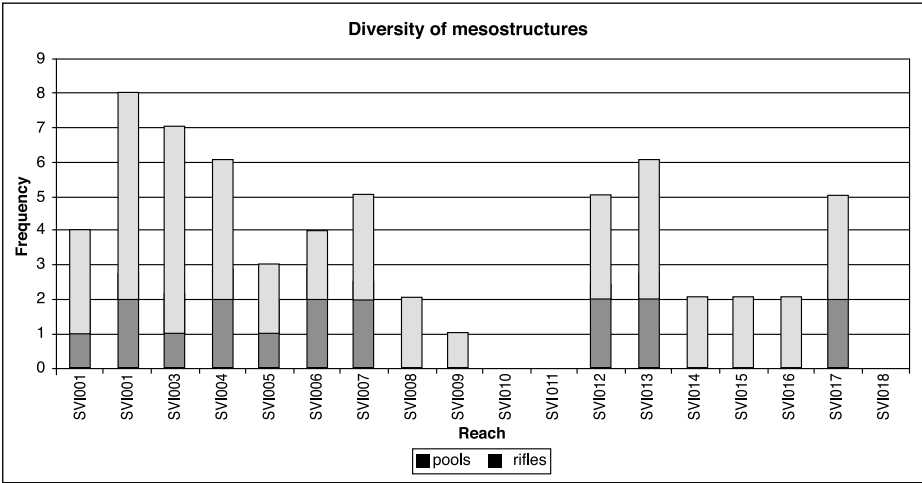
The overall ecomorphological condition of the brook after the restoration can be classified as being in the 2<sup>nd</sup> ecomorphological grade (EG), which means that it is almost natural, affected only mildly by anthropogenic activity. The 1<sup>st</sup> EG has not been achieved mainly because some parameters have not scored good points evaluations, e.g. altered discharge characters (note: the influence of the drainage and the alterations left on the upper part of the brook), banks in some reaches reverted by scattering quarried stone, lower diversity of microhabitats and absence of group vegetation of potentially natural variety in the riparian belt. The restorations carried out have concentrated on unfortifying the channel and planting bank vegetation which was previously planted mainly in line along the banks. However, due to the instability of the banks, some trees have died. The restoration did not include planting the riparian belt in the wider surrounding of the brook. The 4<sup>th</sup> EG was recorded in only one assessed section (in SVI011). This is a section where the brook flows through the bridge culvert under the road Prachatice-Zbytiny. The alteration carried out affects the low diversity of hydromorphological mesostructures and microstructures in the given section and in the adjacent sections – see Fig. 12.

Figure 12: Diversity of hydromorphological mesostructures in the restored reach – number of riffles and pools in individual sections
