# ANTHROPOGENIC RIVER ALTERATIONS AND THEIR EFFECTS ON THE FLOOD SITUATIONS (BÍLINA RIVER CASE STUDY)

**Keywords:** flood, risk, HEM-F, Bílina River, river alteration

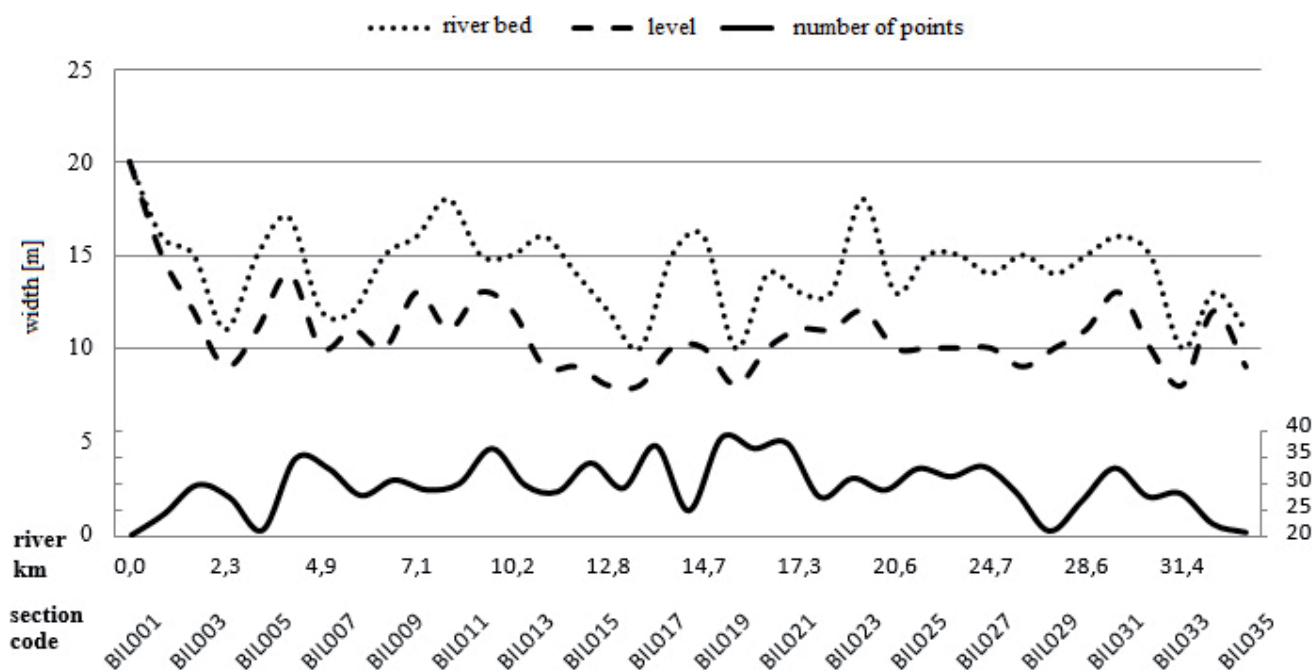
**Fig. 2** The riverbed width and level in kilometres.

Note: The water level on 12 April 2014, when the segment was mapped, at the specific station Trmice (river km 3.80) was 1039 mm, with a flow of  $3.81 \text{ m}^3 \text{ s}^{-1}$ . During the mapped period from May to October 2014, the level of this station ranged from 1000 mm (lowest status on September 5, 2014) to 1380 mm (highest status on September 20, 2014). The average water level was 1117 mm during the year.

levels and their differences (Figure 1). The figure shows that in areas with the highest degree of anthropogenic influences the riverbed (the urban areas) is the width of the channel and almost on the same level (see the first 1.5 km, which crosses the city of Ústí nad Labem). This means that the riverbed is mostly concreted or otherwise modified. The distance between the curve gradually increases as the river leaves the built-up area. When the water flow passes through less anthropogenically influenced areas, the variability of the riverbed width and level is high. In relatively natural sections the difference can be up to between 5–7 m. These are segments of higher ecological value, natural vegetation and with greater retention potential in cases of elevated water levels.

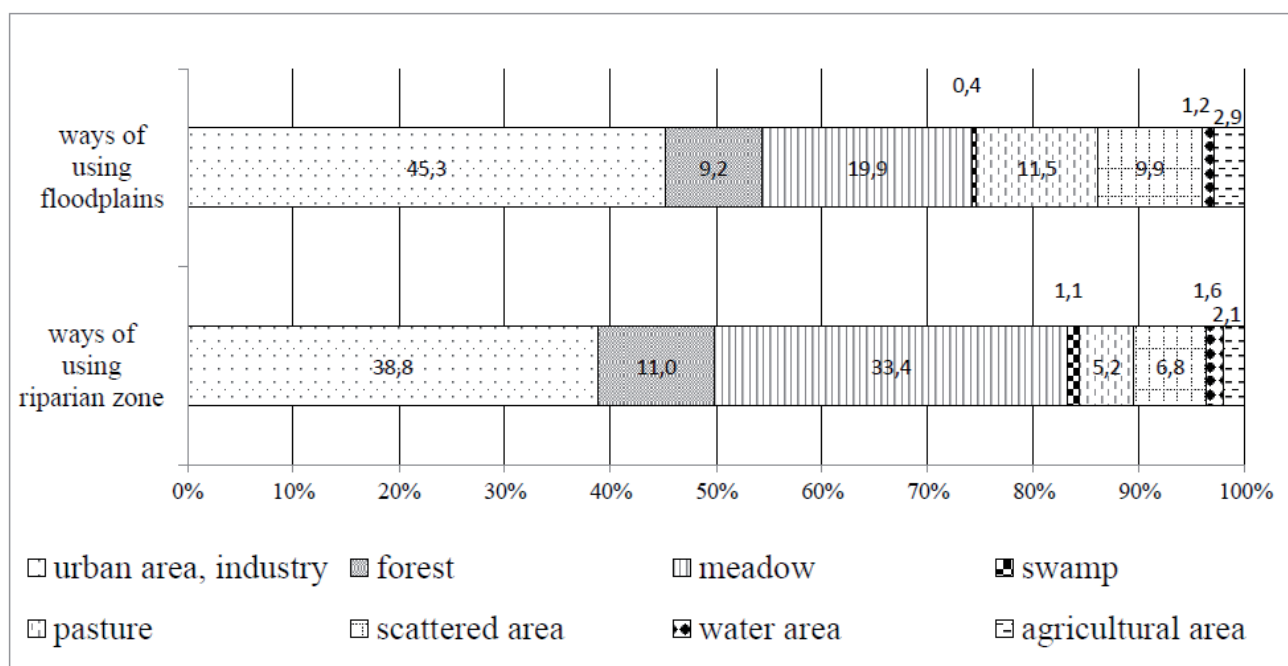
Fig. 6 Percentage of land cover using in the reporting period.

vegetation. Eight main types of use of the riparian zone and floodplains were recorded when mapping the area. All these types of use along both mapped categories correspond to its share. Most are urban and industrial areas. Of the total length of the mapped stream the water flows directly through 17 municipalities, which is over 40% of the length of the flow. More than 30% of the floodplain and over 35% of the riparian zone are used as meadows or pastures. These areas are suitable for the natural overflow of the river at time of increased flood flows, but they do not have such an interception rate as forests, of which there is only about 10% percent in both categories. The mapped area is also suitable for intensive agricultural production in terms of its climatic and geomorphologic characteristics, but the category of agricultural area is less than 3%. The multiple buildings category is also below 10%. These are areas of isolated buildings, especially on the edges of a municipality or outside. These buildings are a particular problem because they are often right near the riverbed, less than 7% in the riparian belt. Therefore they are directly threatened by flood situations.

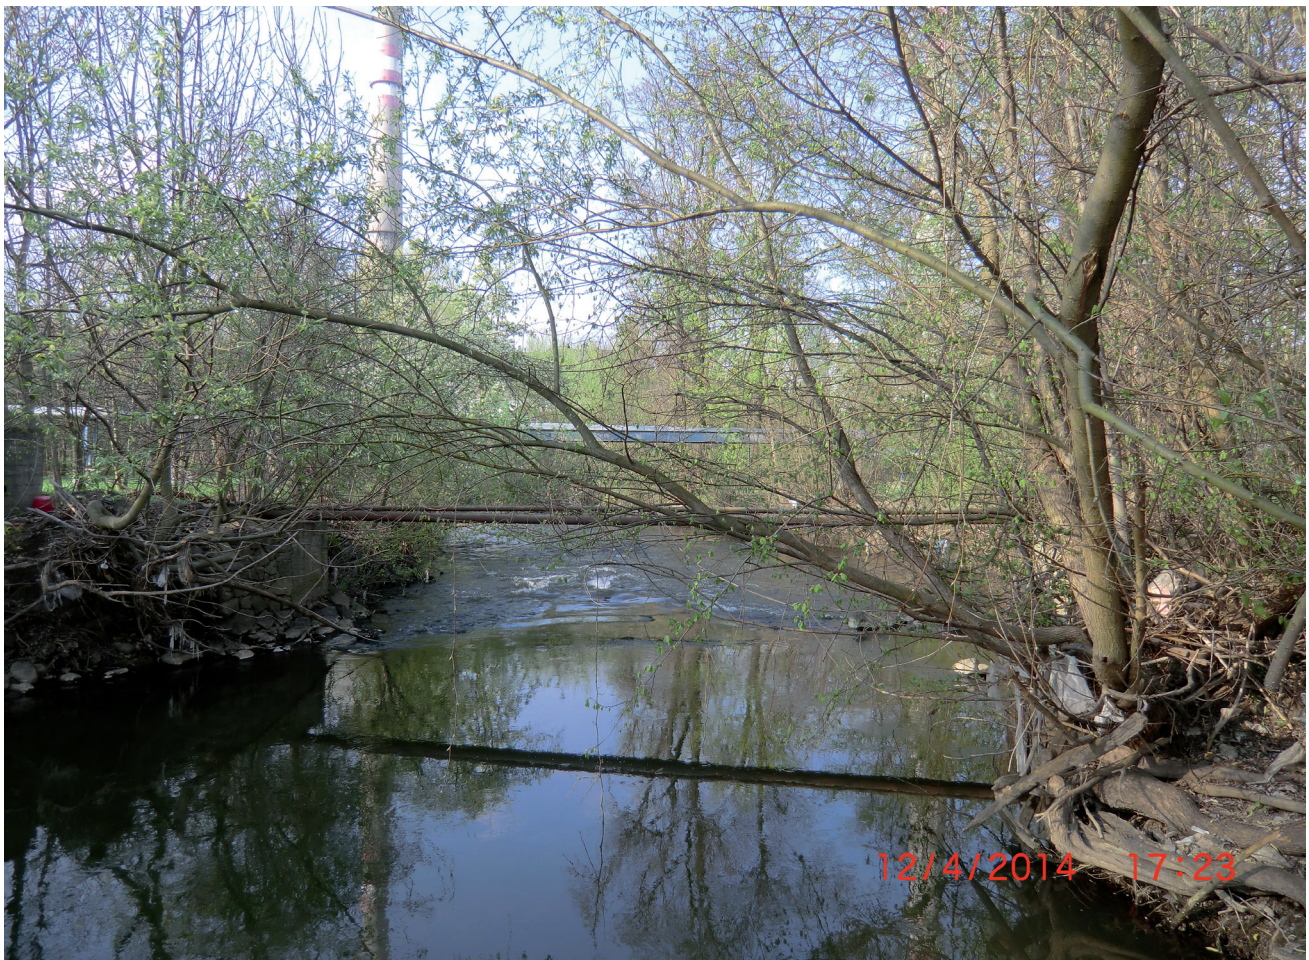
**Fig. 8** Riparian vegetation and silt extending into the riverbed.

Reach BIL007, vegetation extending into the riverbed that could collect silt. This narrowing of the riverbed silt, along with a conduit across the river could cause clogging of the riverbed and water overflowing outside.

| Section code | Title | Description | Regulation proposal |
|---|---|---|---|
| BIL007 | riparian vegetation | riparian vegetation and silt extending into the riverbed | pruning riparian vegetation |

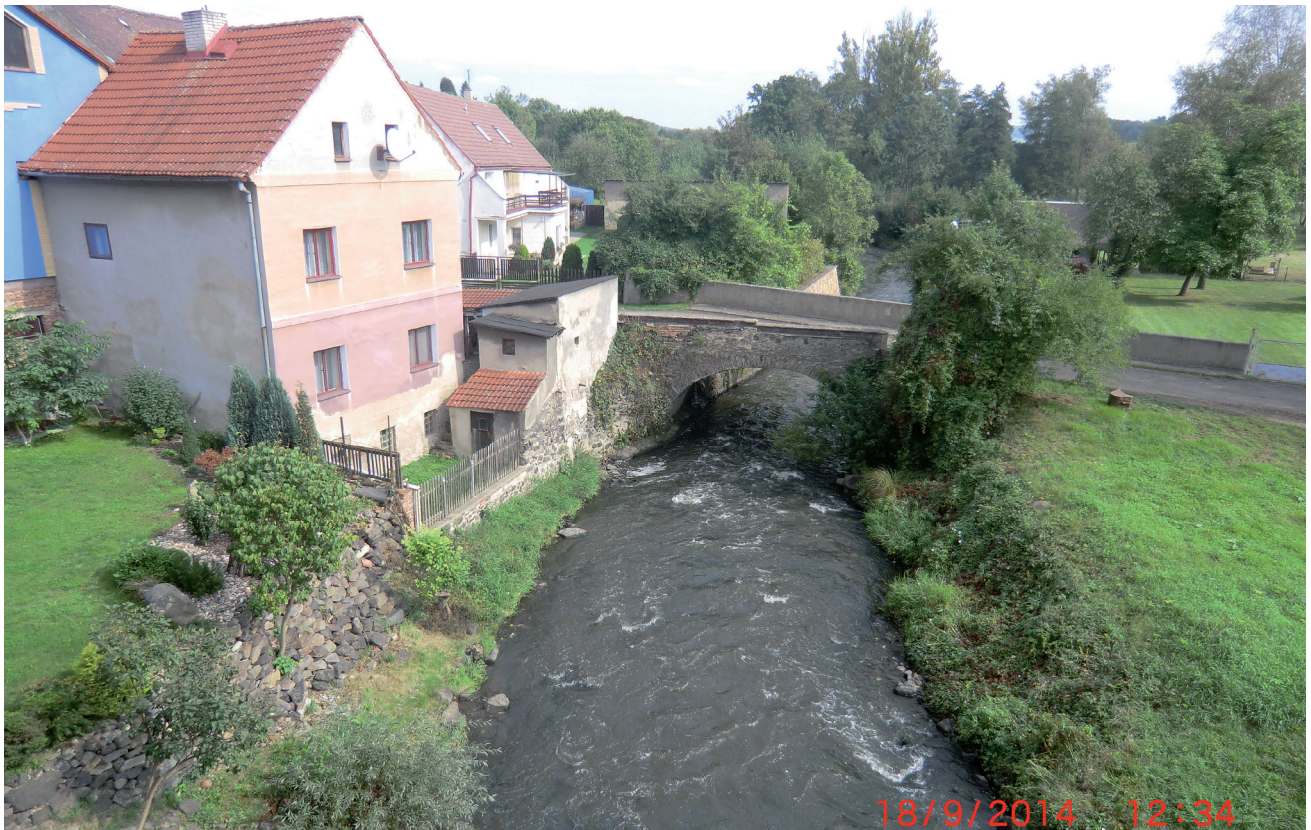
**Fig. 9** The urban village of Rtyně nad Bilinou. Reach BIL019, inappropriately placed buildings directly on the edge of the watercourse. In combination with reduced throughput caused by narrowing the channel profile bridge, high water flows could threaten buildings along the river channel.

| Section code | Title | Description | Regulation proposal |
|---|---|---|---|
| BIL019 | urban village of Rtyně Bílinou | inappropriately placed buildings directly on the edge of the watercourse | construction elements of flood protections around the buildings |

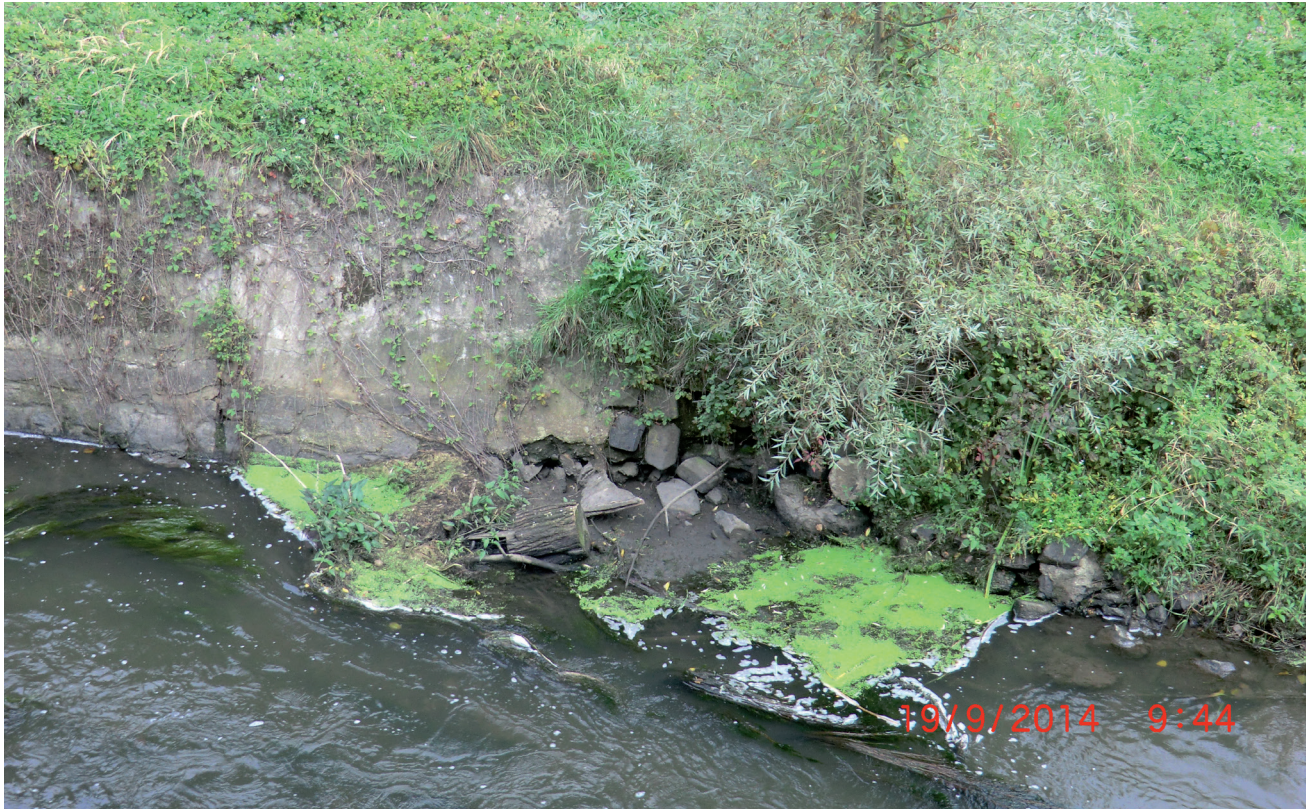
**Fig. 10** Destroyed concrete adaptation shore. Reach BIL029, because of the riparian vegetation and water destroying the concrete bank fortifications and lateral water erosion the situation before the bridge over the river could eventually disrupt the bridge structure and scour the adjacent road.

| Section code | Title | Description | Regulation proposal |
|---|---|---|---|
| BIL029 | destroyed concrete adaptation shore | destroying the concrete bank fortifications and lateral water erosion | repair fortifications by river trustee |

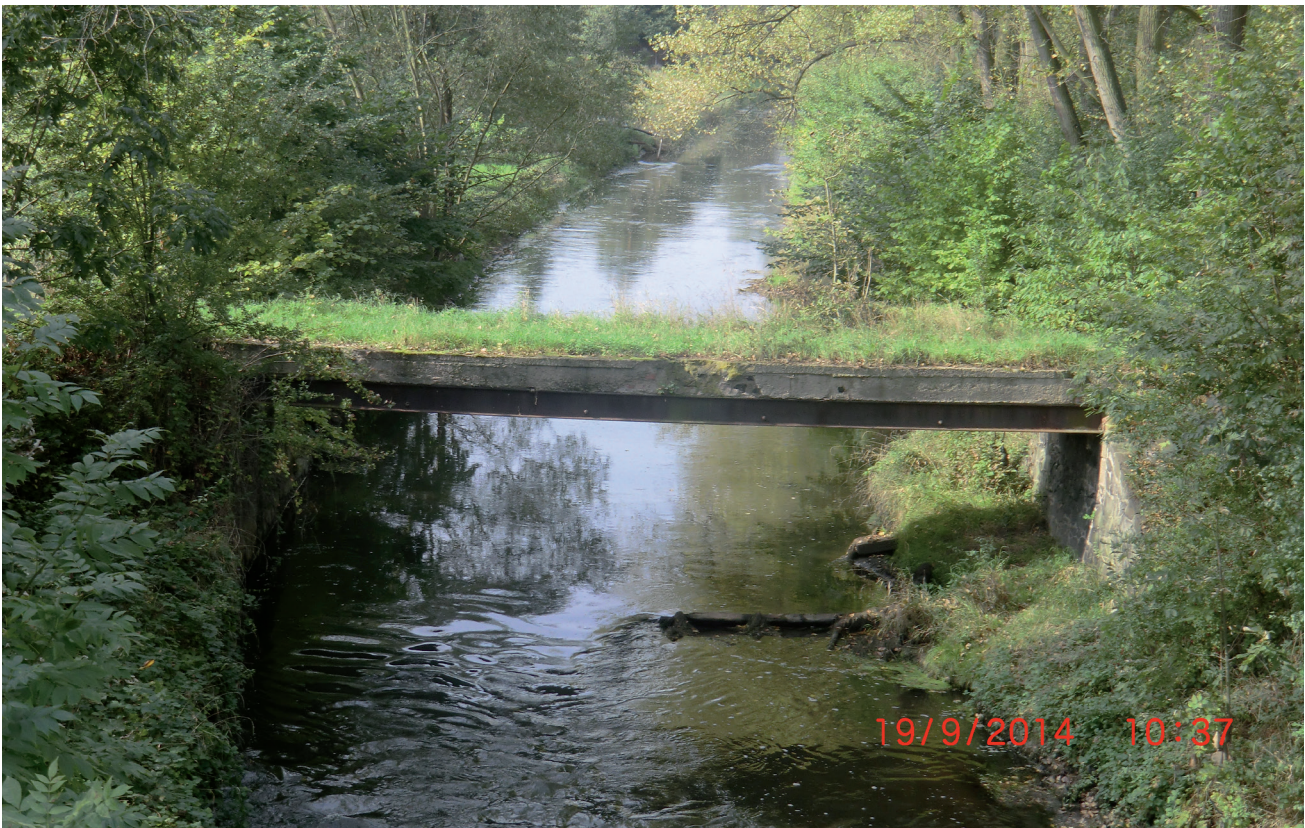
**Fig. 11** Old bridge.

Reach BIL032 stretch of an old concrete bridge over the river, which is in disrepair and threatening to collapse into the riverbed. This could clog the riverbed and make the water overflow.

| Section code | Title | Description | Regulation proposal |
|---|---|---|---|
| BIL032 | old bridge | old concrete bridge over the river, which is in disrepair and threatening to collapse into the riverbed | repair or remove of the bridge |
