Dam breach reconstruction of the Blažňov pond caused by extreme hydrological event

MIROSLAV ŠOBR, MICHAL JENÍČEK, KLÁRA VOČADLOVÁ

Charles University in Prague, Faculty of Science,
Department of Physical Geography and Geoecology

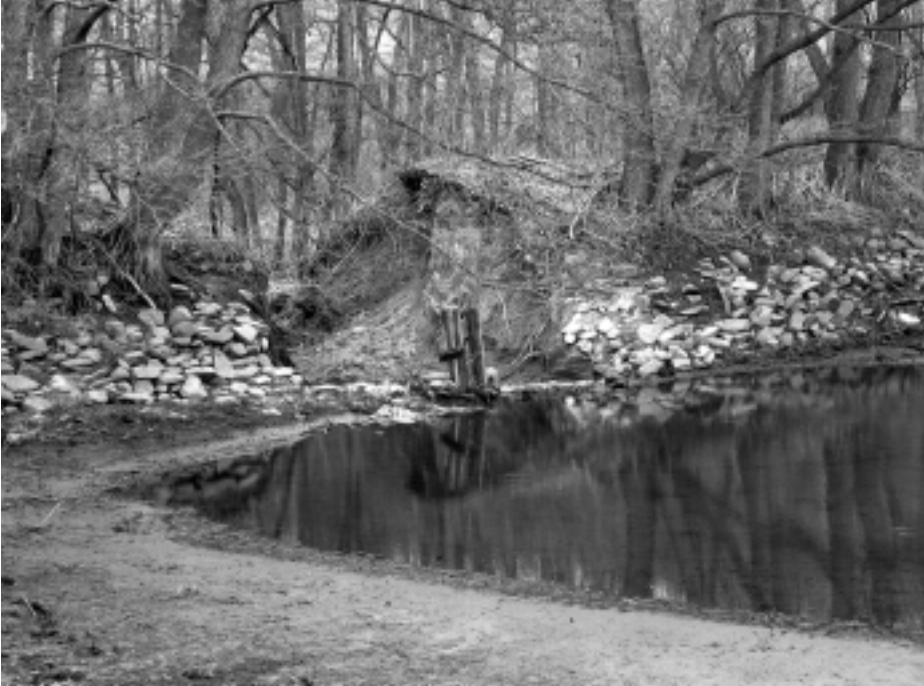
Fig. 1: The Blažňov pond after the dam breach. The depth of the rest of water in the pond was 0.3 m

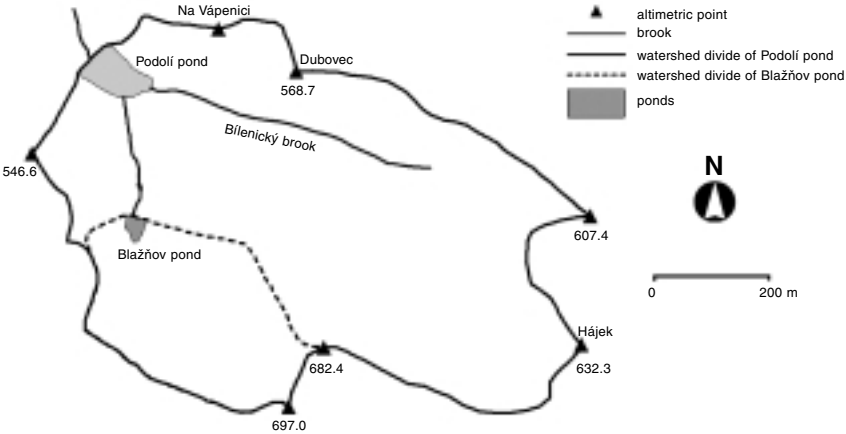
Fig. 2: Schematic map of the study area

The breach was followed by the flood wave that overcame the distance of 570 m (mean slope gradient 2.8 %) and flew into the lower situated pond Podolí (497 meters above sea level; see Fig. 2) where it transformed. On March 22, 2006 the

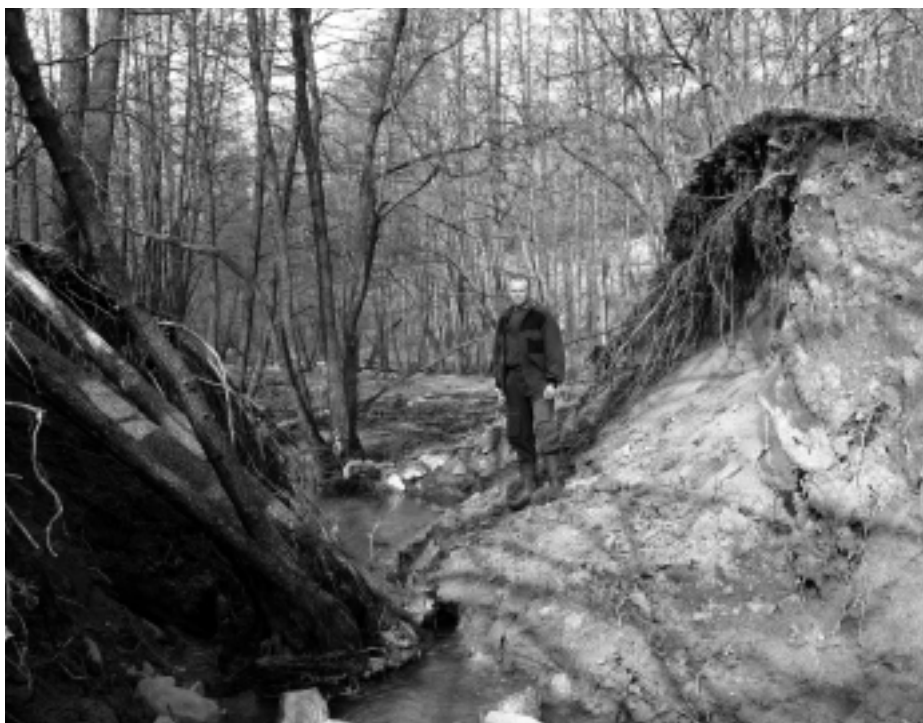
The flood wave that occurred after the dam breach did not cause any serious damages. The first part of the valley of the stream is characteristic by the forest with full-grown trees, the other part continues through the channelized trapezoidal river bed up to the mouth into the pond. Water left the river bed but no damages occurred on the surrounding pastures excepting washed-up wooden pieces. In the upstream part remained spacious sediments of sand gravel originated from the pulped dam, as thick as up to 30 cm (Fig. 3). The overall cubic content of the material moved by water from the dam was calculated to 253 m³.

Fig. 3: Detail of the damaged dam of the Blažňov pond

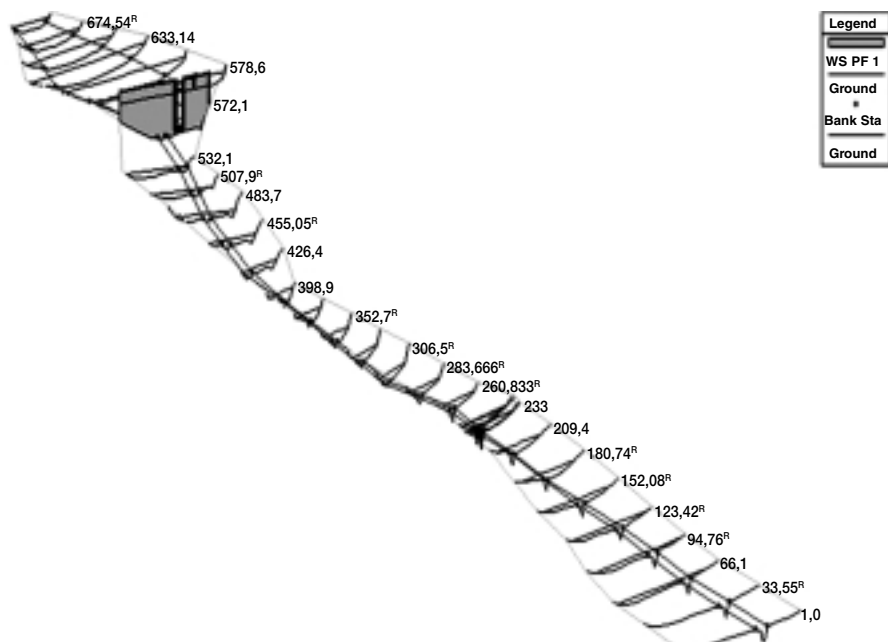
Fig. 5: The 3D scheme of the river network in the HEC-RAS model. Blažňov pond is situated in the upper part of the brook finished with inline structure (represented by grey wall)

HEC-RAS this is represented by geometry editor which allows a creation of complete river network (river reaches, cross-sections, bridges, culverts inline structures, etc.). Cross-sections were situated perpendicular to the floodplain and riverbed and they were measured with the help of TPS (total geodetic station). In consequent processing an automatic interpolation of cross-sections was necessary to carry out, in order to avoid equation instabilities. Together 29 cross-sections were measured, derived from digital terrain model (DTM) or interpolated. Additional information such as Manning's n values for the riverbed, left and right floodplains were added as the cross-section properties. One culvert has to be simulated in the downstream part of the reach. The dam of the Blažňov pond was represented by inline structure with spillway structure. The 3D schema of the river network is displayed in the Figure 5.

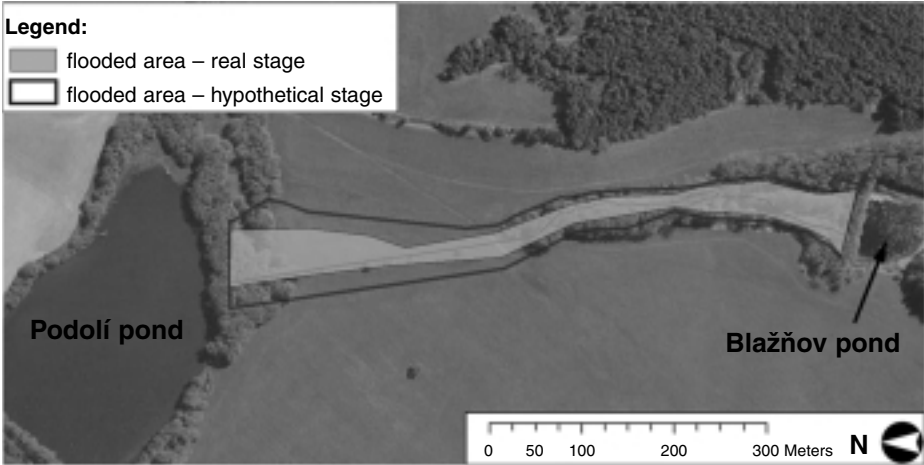
Based on these facts the second theoretical simulation was carried out. This simulation supposed the same water level in the pond as it was before destruction of the dam. In this case a peak flow reached $56.6 \text{ m}^3 \cdot \text{s}^{-1}$ and the area of $26\,870 \text{ m}^2$ was flooded. The main results are concluded in the table 1. The flooded area for both simulations is displayed in the Figure 6.

Fig. 6: Flooded area for both simulated variants – real stage (calibrated by means of measured data) and hypothetical stage (suppose sudden breaching with time of destruction close to zero and with maximal water level)

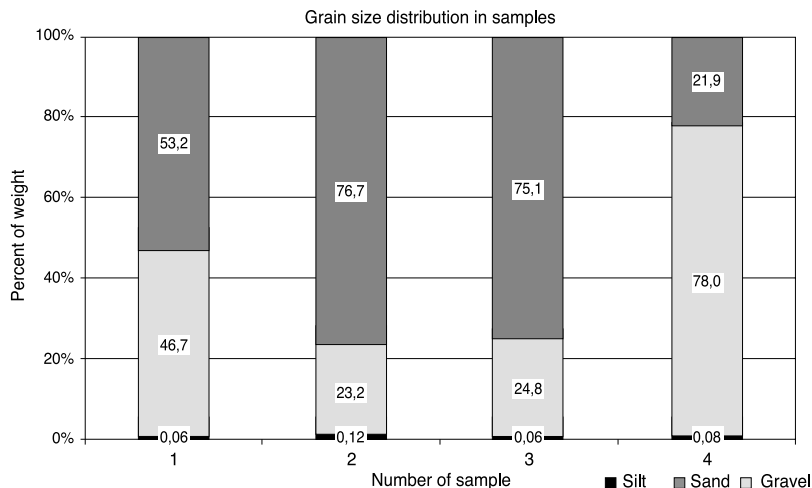
The flow velocity as well as the grain size of transported and deposited materials depends on the flood phase and on the river reach. Gravel is transported simultaneously with the sand. When the flow velocity decreases, the gravel sediments and the sand is transported until additional velocity decreasing (Růžičková et al., 2003). This was proved also by obtained sediment samples, where the probe no. 4 (obtained within the largest distance from the broken dam) displays three times higher abundance of sand fraction compared to probes nos. 1, 2 and 3 (see Fig. 8).

Fig. 8: Grain size distribution in samples

In all probes the ratio of gravel and sand fractions coincidentally outweighs over the fine-grain material of the grain size under 0.05 mm (Tab. 2). The probes no. 1 and no. 3 are the most similar regarding the grain compositions. The coarsest sample is the probe no. 2 (fine gravel, grain size approx. 5 mm). Grain size distribution of samples 1 and 3 corresponds to sand and gravel and sample 4 contains particles from 1 to 2 mm (sand).

The grain-size distribution curves analysis documents reduction of the carrying capacity down the stream from the Blažňov pond dam which was documented by increasing ratio of fine-grain components in removed samples. The flow velocity within the whole length of the water stream was so high that no fine-grain sediments (silt and clay) settled down. It is assumed that sedimentation of particles took place in the Podolí pond.
